Safety and Operational Issues Memo

Project: Lowcountry Rapid Transit (LCRT)

Subject: Safety Memorandum – Rivers Avenue

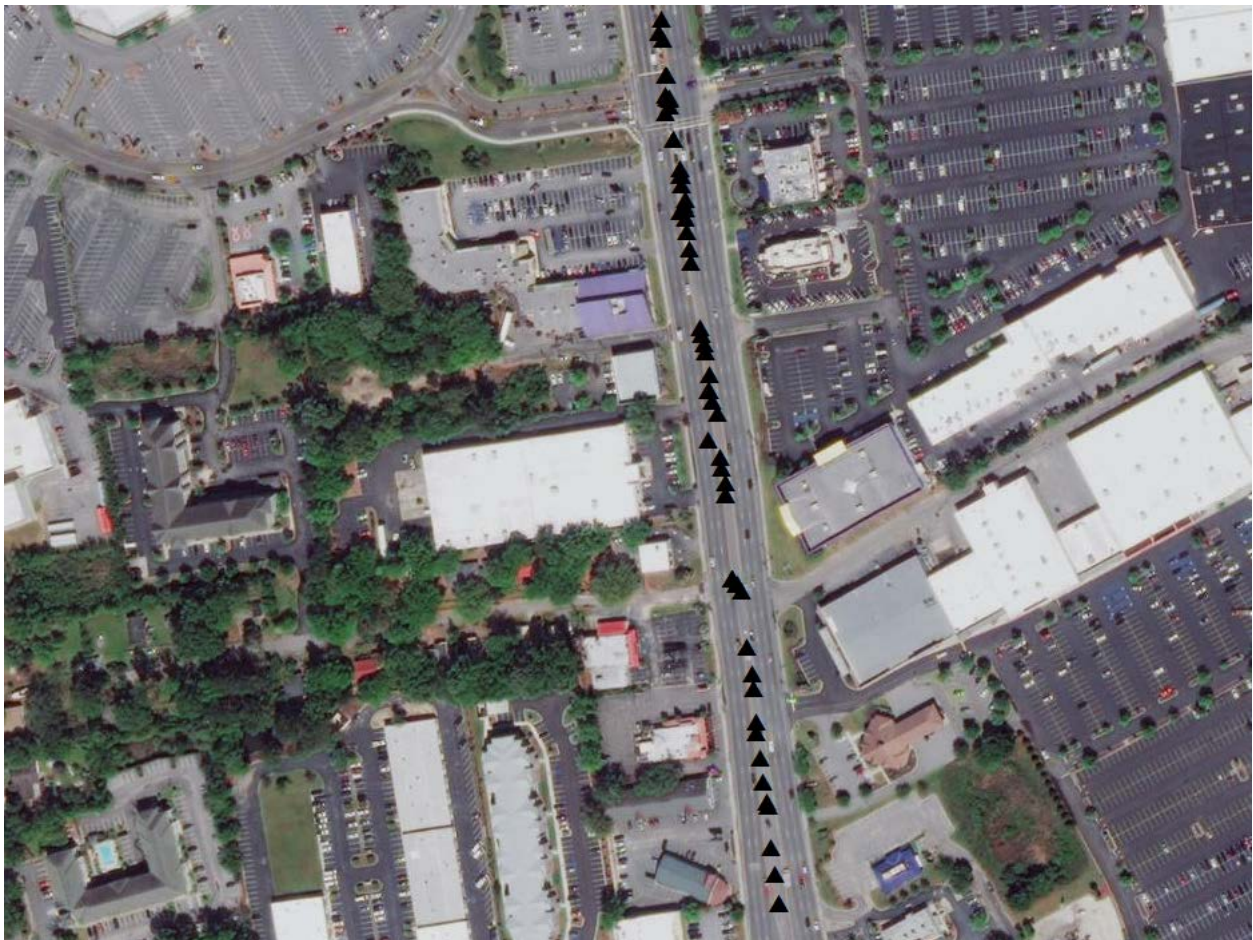
Example of Angle (black) Crashes in Center Turn Lane from Northwoods Blvd to Ashley Phosphate Rd

A section of Rivers Ave between Northwoods Boulevard and Ashley Phosphate Road is noted as being a location where angled crashes frequently occur, likely due to the numerous driveways and the unrestricted left turn access to these driveways from the center two-way left turn lane. Additionally, 3 serious injury crashes and 2 fatalities were reported within this section. One fatality was the result of an angled crash and the other was the result of a vehicle striking a pedestrian in the road. Two of the serious injury crashes may have been a result of a vehicle striking a pedestrian as well, given information found in the report dataset. More discussion on pedestrian crossing treatments is found in subsequent sections of this memo.

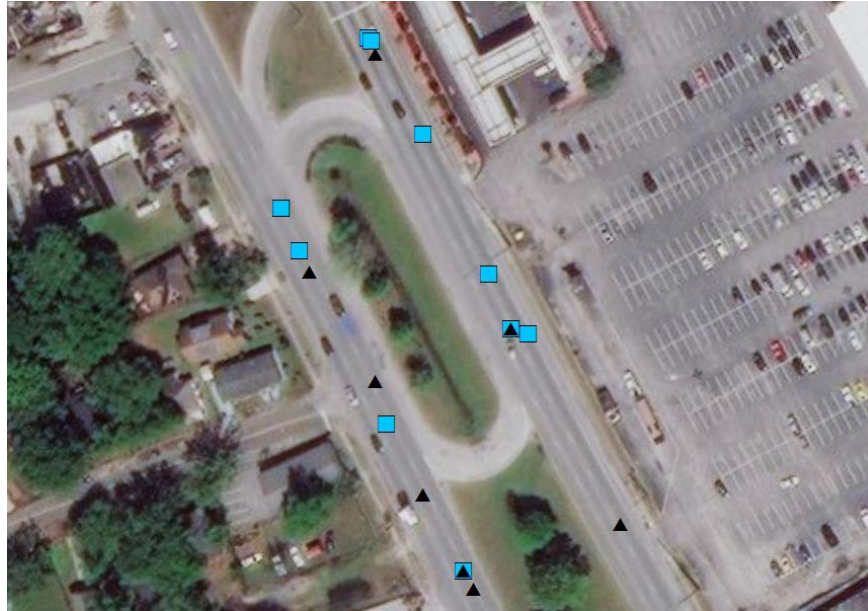
Example of Sideswipe (blue) and Angle (black) Crashes at Rivers Avenue near Liberty Mall U-turns

Throughout the corridor, there is a noticeable clustering of crashes that take place near the unsignaled median U-turn locations and the median left turn crossover locations. As previously noted, angled crashes often occur at left turn crossover locations, where vehicles turn onto a short section of pavement within the median and wait at a stop bar for gaps in opposing traffic. Drivers often treat these crossover locations as places to make U-turns as well, and there is some indication that this movement causes sideswipe crashes. Similarly, median U-turn locations show some indication of being locations where sideswipe crashes occur, as vehicles are often required to make a U-turn into an acceleration lane and make one lane change from the left-hand side of the travel way before the acceleration lane ends.

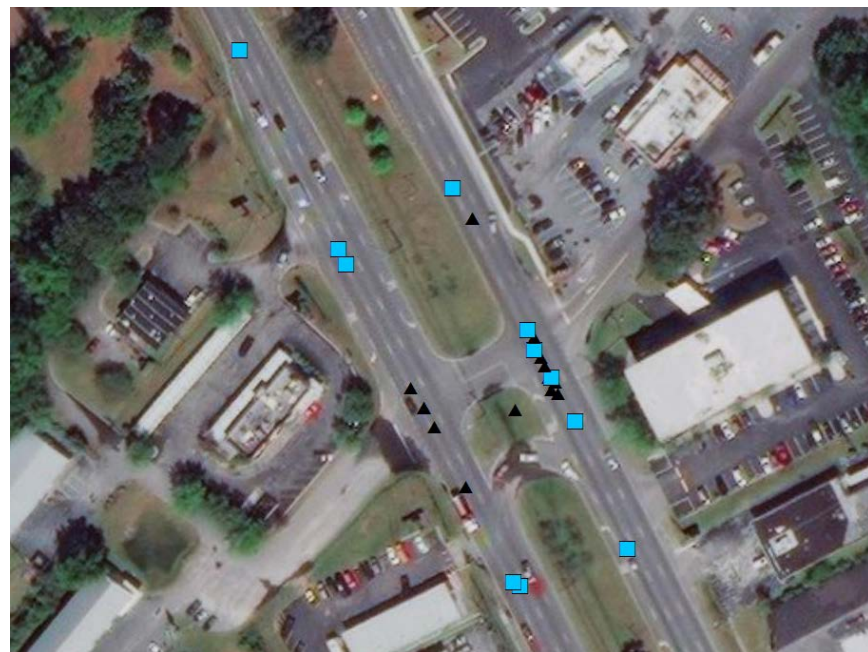
Example of Sideswipe (blue) and Angle (black) Crashes at Rivers Avenue at Hawthorne Drive Crossover

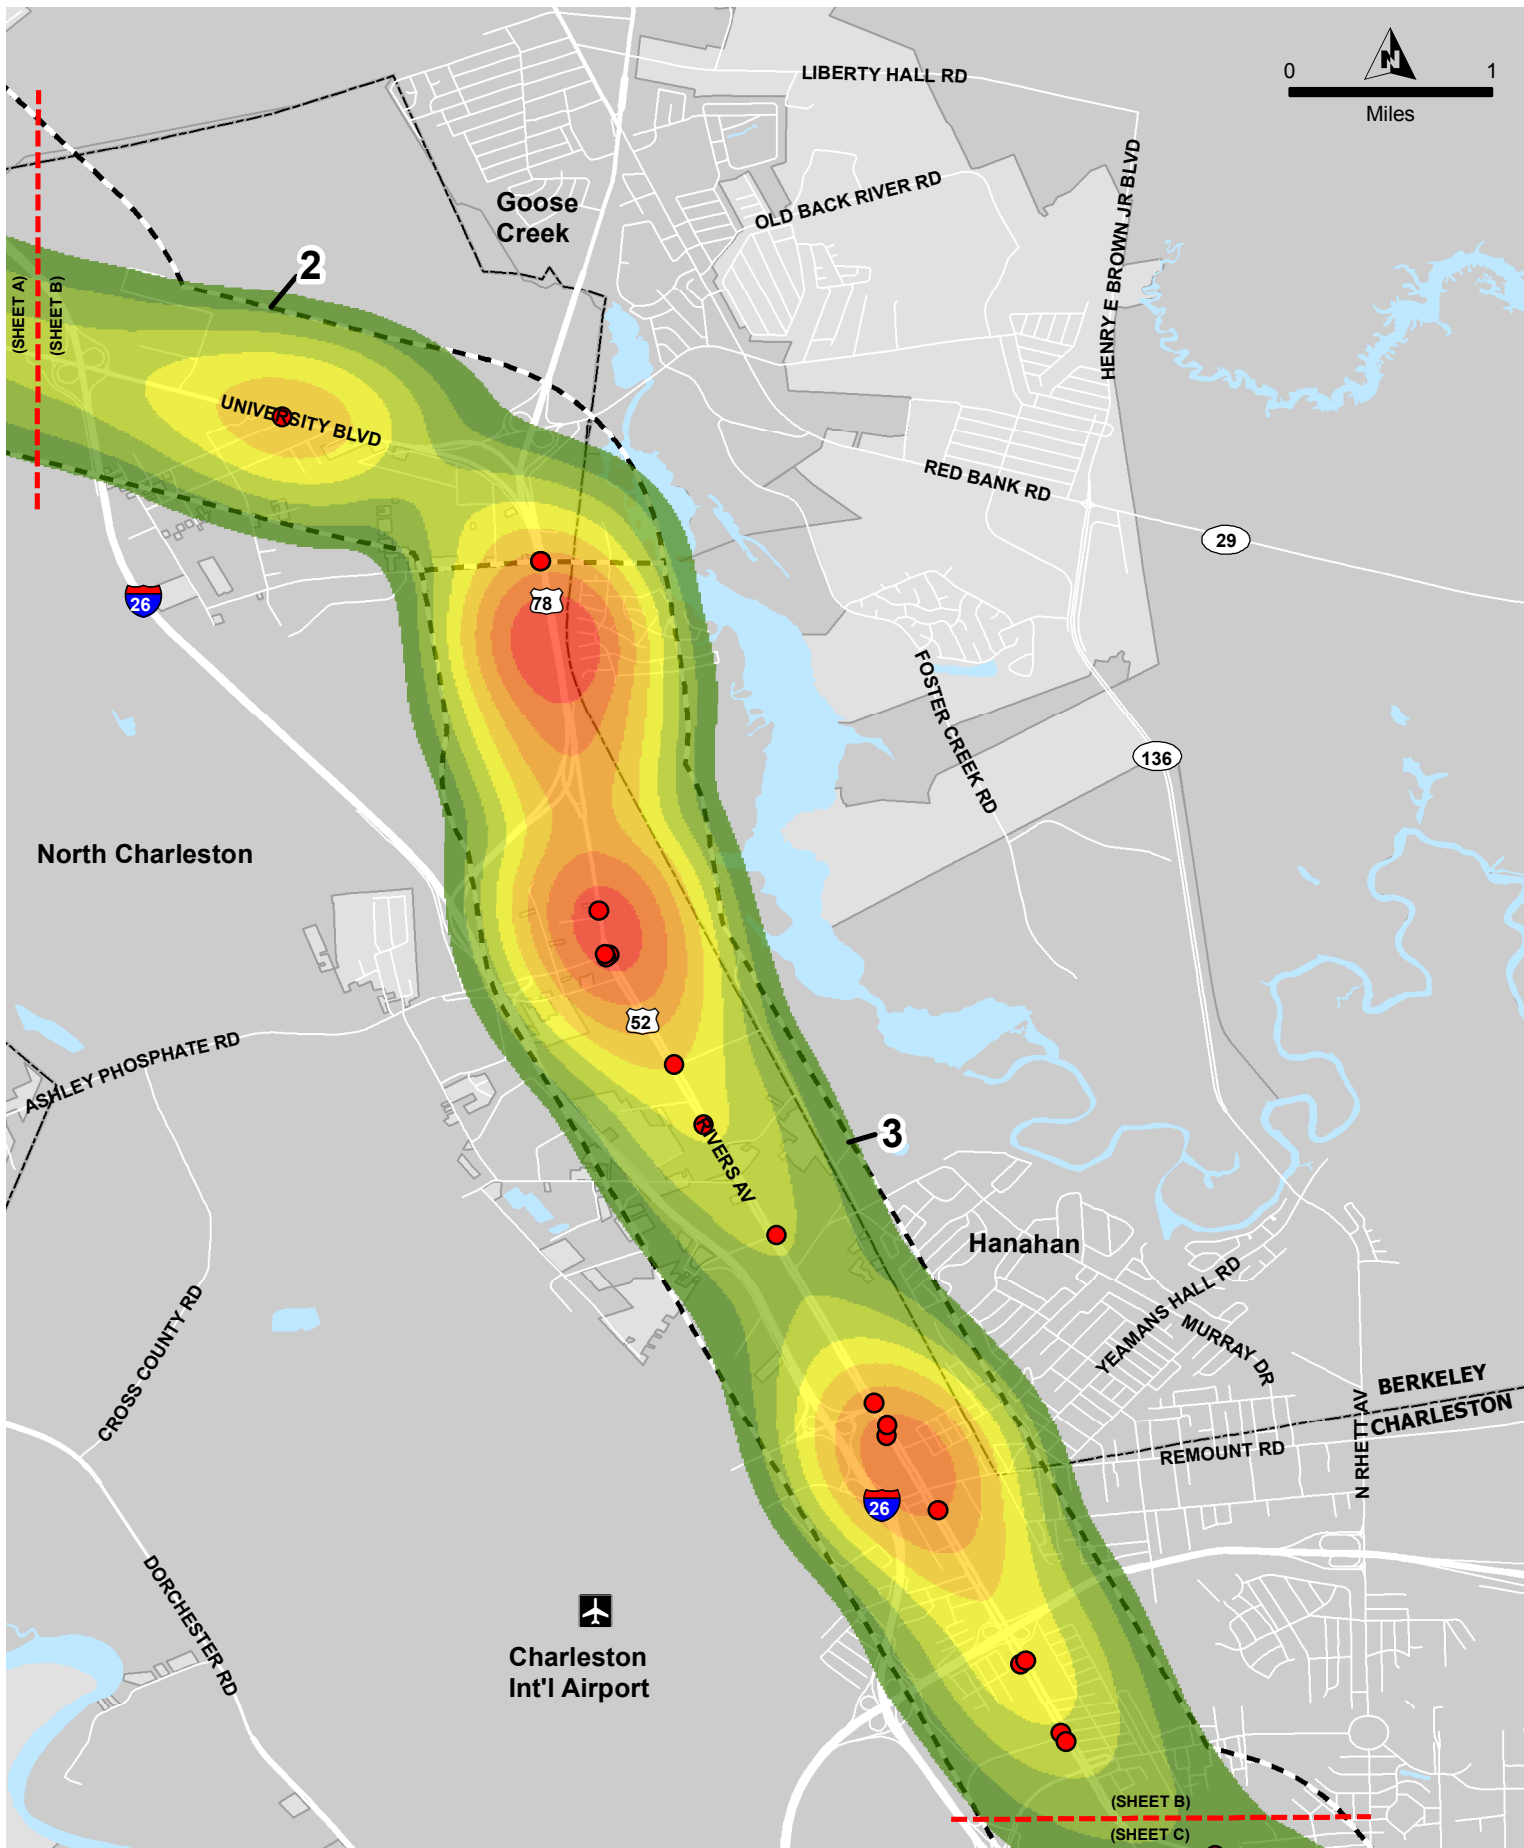
## Lowcountry Rapid Transit Study Area - Sheet A

Data Source: SCDOT, BCDCOG

Angled crashes are a predominant crash type at many of the unsignalized intersections and driveways along Rivers Avenue and are the cause of several serious injuries and motorist fatalities.

Angled crashes are observed at most minor-street intersections, both signalized and unsignalized. This trend occurs throughout the corridor and is largely due to uncontrolled movements in conflict with high volumes of traffic within multiple lanes traveling at high speed.
